January 25, 2021

Reference No. 2008-S135A

**Re: Additional Slope Stability Assessment Letter  
Proposed Residential Development  
Shining Hill Phase 3  
162 St. John's Sideroad  
Town of Aurora**

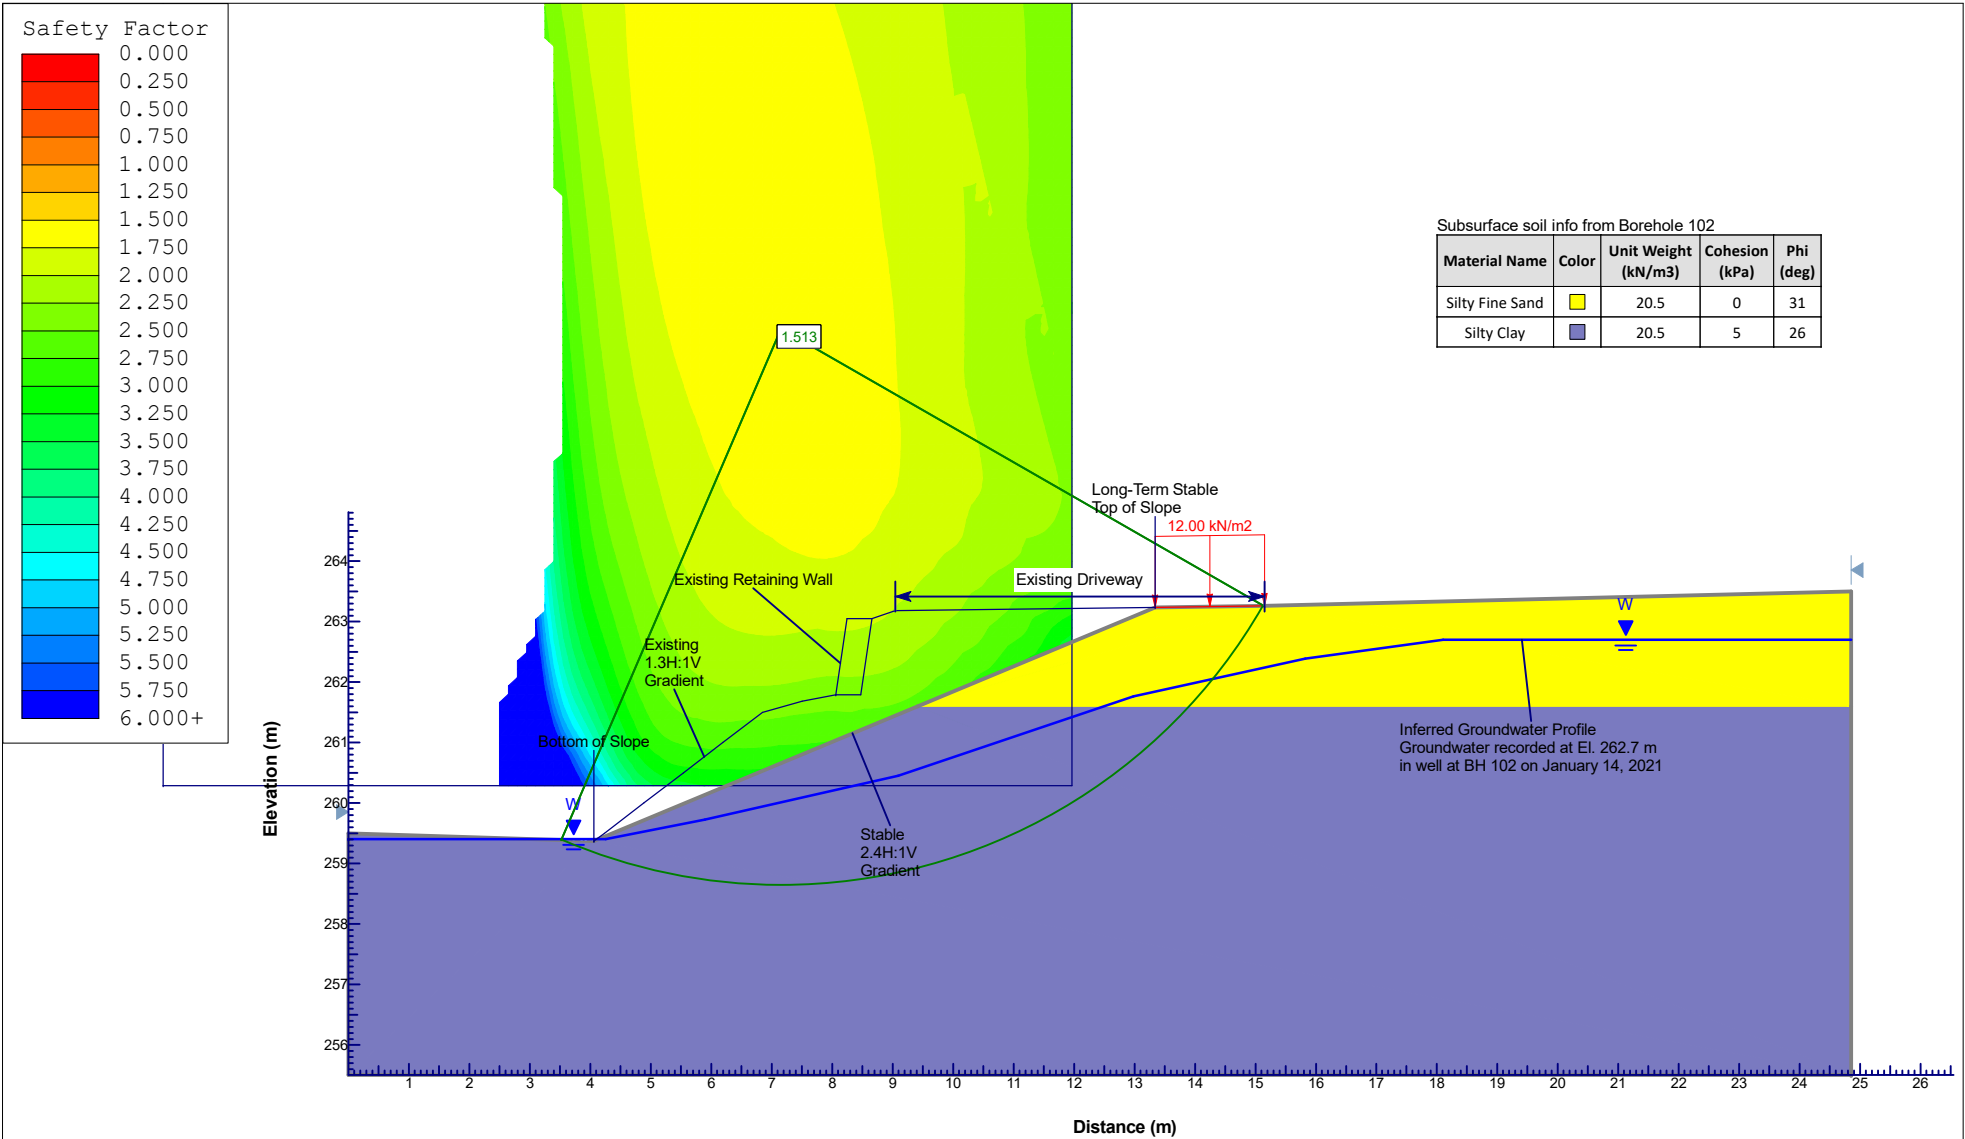
The cross-sections were subsequently reanalysed to determine the stable gradient at the site in order to meet the OMNR requirements for a minimum FOS of 1.5. Based on the reanalysis, the stable gradient was determined to be 2 to 2.7H:1V, depending on location and height. In addition, due to the proximity of the watercourse to the bottom of slope, and considering that no visible sign of active erosion was observed along the bank of the watercourse, the reanalysis at the cross-sections were carried out to incorporate a 2.0 m toe erosion allowance based on the OMNR guidelines, where applicable. The results of the reanalyses at Cross-Sections H-H, I-I and J-J are presented on Drawing Nos. CS3, CS5 and CS7, respectively, and show that with the incorporation of the toe erosion allowance and stable gradients, the resulting minimum FOS were determined to be 1.513, 1.538 and 1.567, respectively; therefore, the incorporated stable gradient projected to the top of slope can be considered the stable top of slope.
