November 19, 2021
(Revision of report dated January 25, 2021)

Reference No. 2008-S135A
Page 1 of 5

**Re: Additional Slope Stability Assessment Letter
Proposed Residential Development
Shining Hill Phase 3
162 St. John's Sideroad
Town of Aurora**

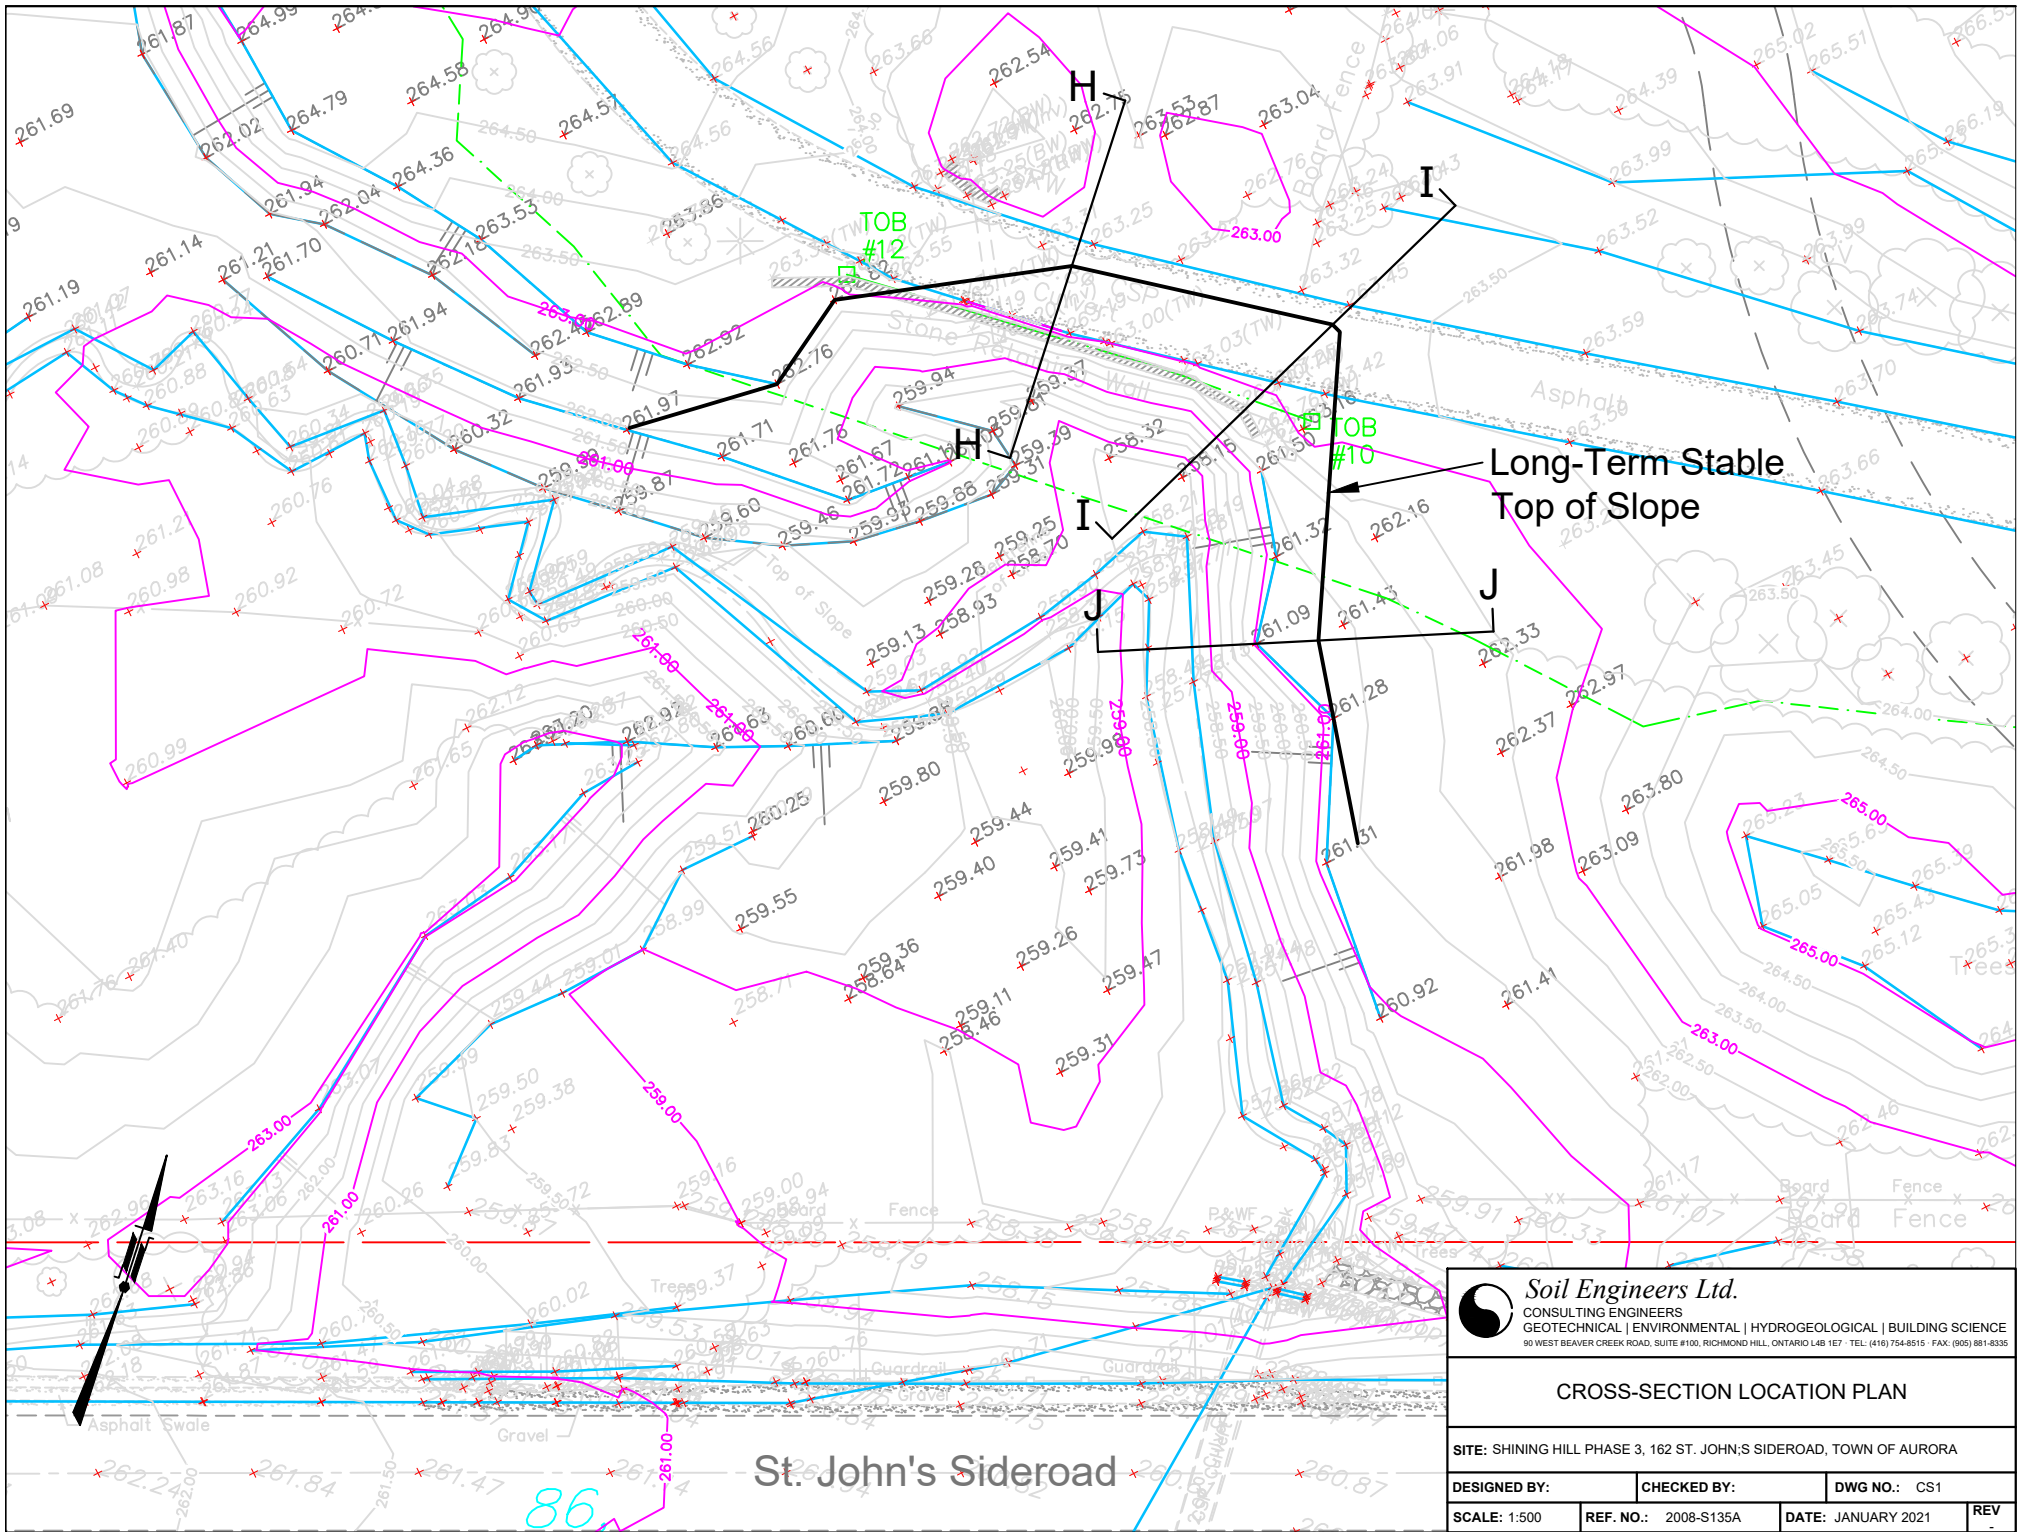
DESIGNED BY:	CHECKED BY:	DWG NO.: CS1
SCALE: 1:500	REF. NO.: 2008-S135A	DATE: JANUARY 2021
		REV

The LTSTOS based on the slope stability analysis has been established on Drawing No. CS1, and shows that the LTSTOS lies generally beyond the physical top of slope, due to the steepness of the existing slope. The established LTSTOS has also been overlaid on the provided Draft Plan, as shown on Drawing No. CS8. Furthermore, a development setback for man-made and environmental degradation will be required from the LTSTOS. This is subject to the requirements of the Lake Simcoe Region Conservation Authority (LSRCA).

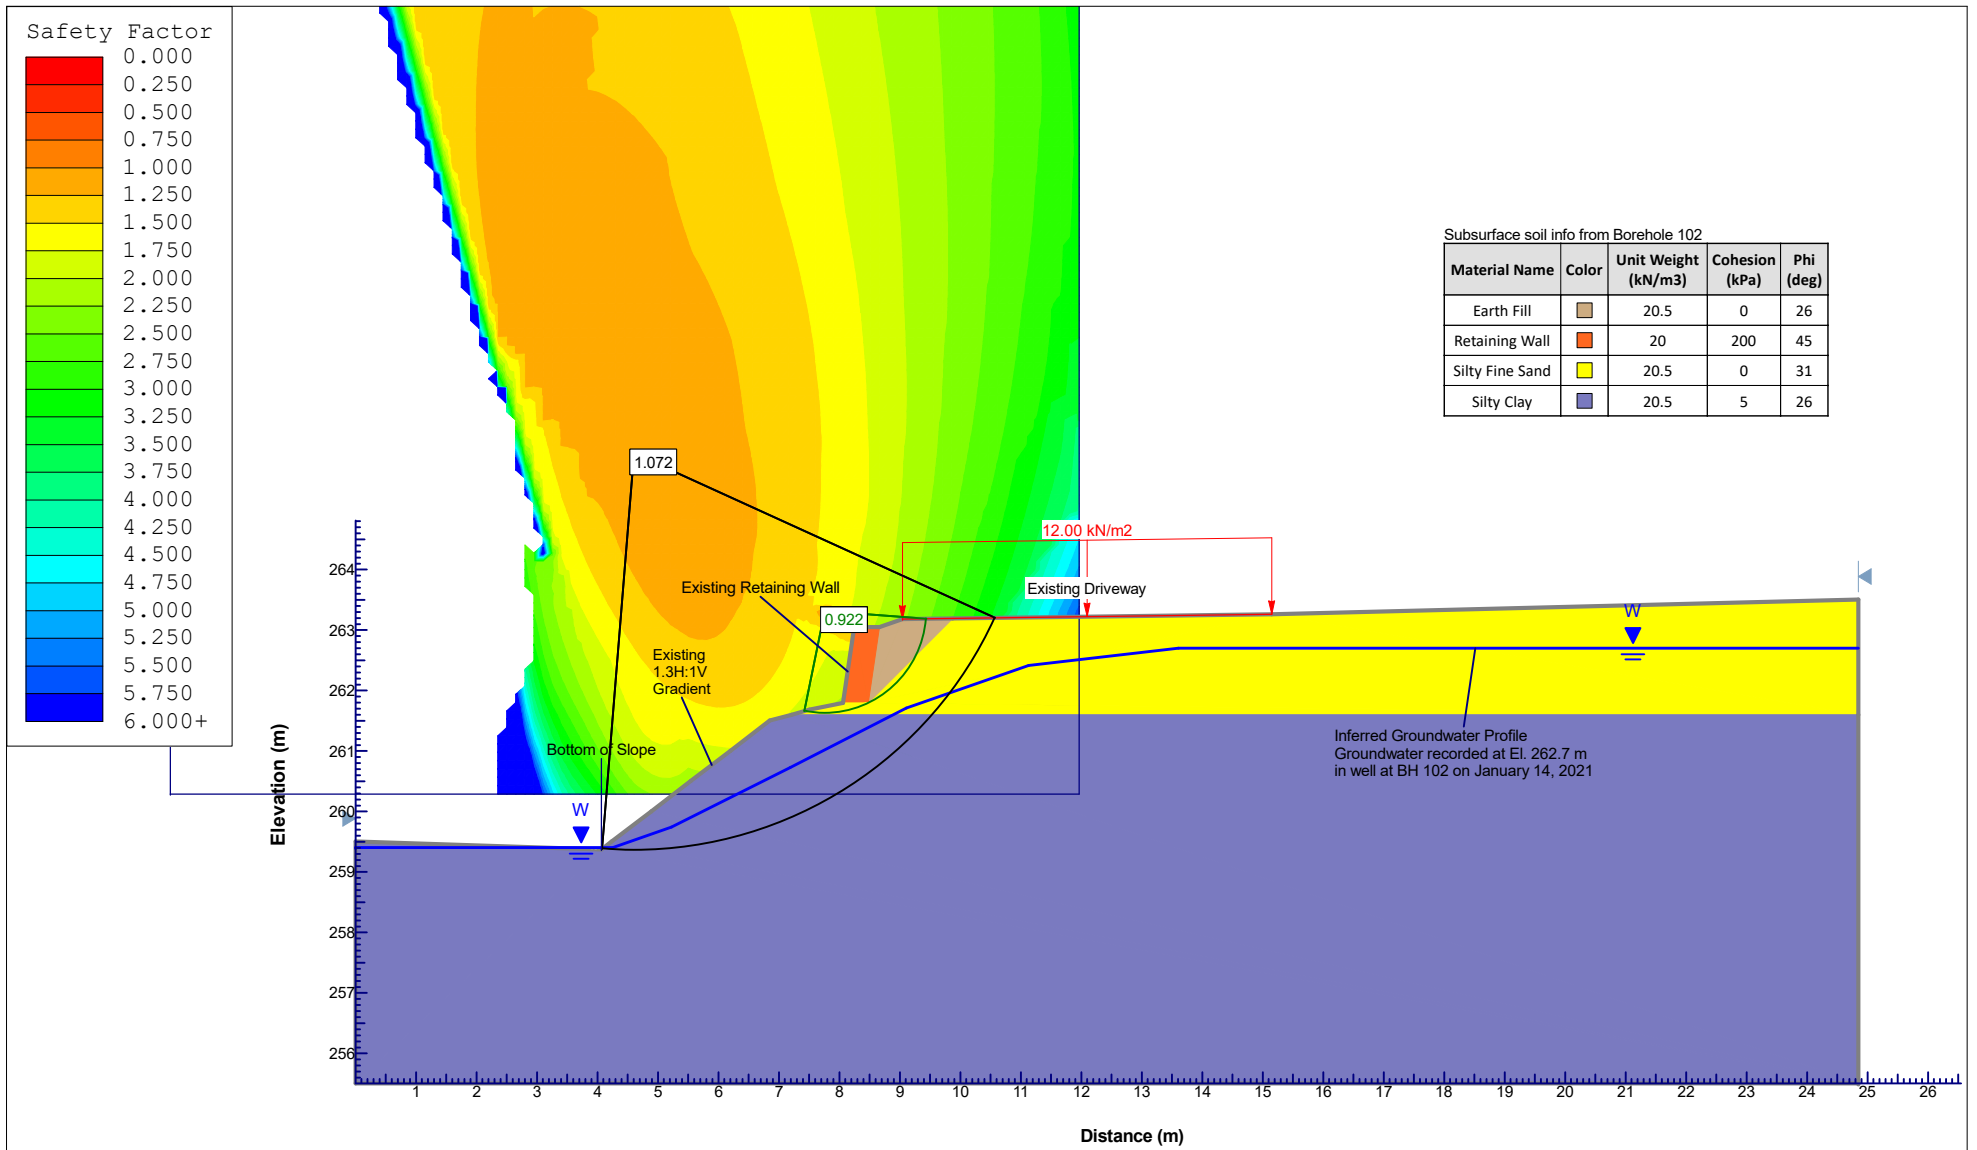
The results of the analyses at Cross-Sections H-H, I-I and J-J, under existing conditions, shows that the minimum FOS is calculated to be 0.922 to 1.276, which fails to meet the Ontario Ministry of Natural Resources (OMNR) guideline requirements for active land use (minimum FOS of 1.5); the results of the analyses are presented on Drawing Nos. CS2, CS4 and CS5 for Cross-Sections H-H, I-I and J-J, respectively.

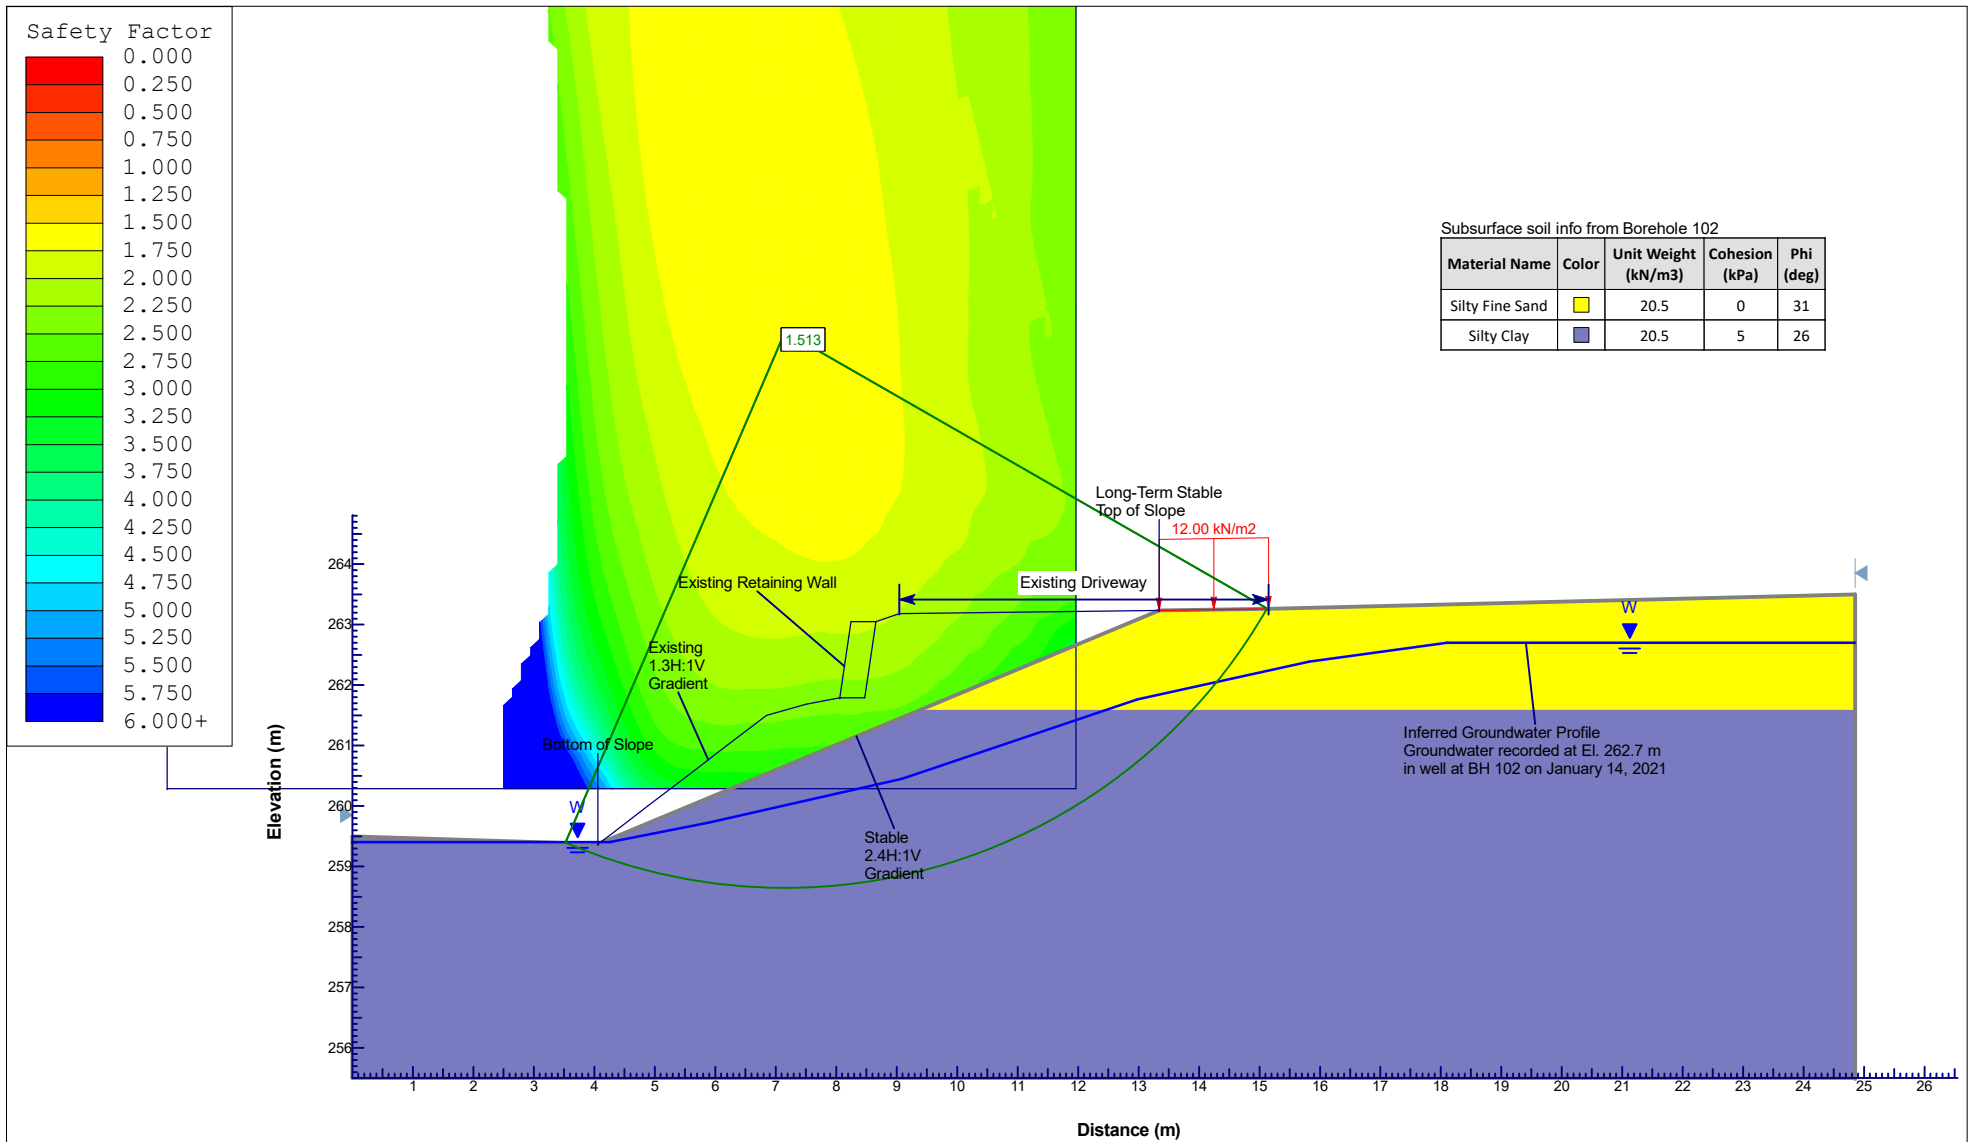
The cross-sections were subsequently reanalysed to determine the stable gradient at the site in order to meet the OMNR requirements for a minimum FOS of 1.5. Based on the reanalysis, the stable gradient was determined to be 2 to 2.7H:1V, depending on location and height. In addition, due to the proximity of the watercourse to the bottom of slope, and considering that no visible sign of active erosion was observed along the bank of the watercourse, the reanalysis at the cross-sections were carried out to incorporate a 2.0 m toe erosion allowance based on the OMNR guidelines, where applicable. The results of the reanalyses at Cross-Sections H-H, I-I and J-J are presented on Drawing Nos. CS3, CS5 and CS7, respectively, and show that with the incorporation of the toe erosion allowance and stable gradients, the resulting minimum FOS were determined to be 1.513, 1.538 and 1.567, respectively; therefore, the incorporated stable gradient projected to the top of slope can be considered the stable top of slope.
