**Heritage
Advisory Committee
Meeting Agenda**

**1. HAC19-001 – Request to Remove a Property from the Aurora Register of Properties of Cultural Heritage Value or Interest
97 Wellington Street East**

The purpose of this report is to provide Council with recommendations from the Heritage Advisory Committee regarding the request to remove the property located at 97 Wellington Street East from the Aurora Register of Properties of Cultural Heritage Value or Interest.

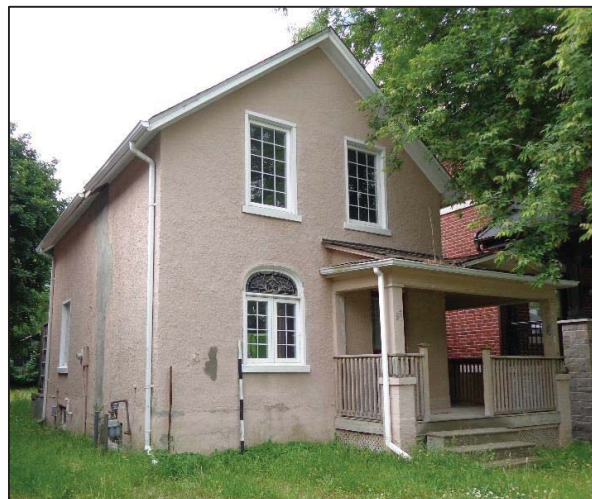
*Figure 5.1
House at 97 Wellington Street East,
East and North Elevations, 2018*

The House, excluding the veranda, is setback between 5.64 and 5.89 metres (18.5 and 19.3 feet) metres from the north property line, which is close to the sidewalk. The House is a single detached, one and one-half storey frame structure clad in rough cast (stucco). The House rests on a poured concrete foundation, which is not visible from the exterior.

The property was documented in photographs and measured floor plan sketches. The House is a 1 ½ storey frame structure clad in stucco with a poured concrete foundation and a gable roof with the gable facing the street. It has a one storey veranda extending around the north-west corner. It was designed in a vernacular interpretation of Edwardian Classicism, but lacks many of that style's details. It has been altered, although the basic form, massing and fenestration of the structure remain intact. The veranda has been reduced in length across the principal elevation and all windows, save a stain glass transom, have been replaced with modern sash. The landscape consists of a small, grassed front yard with a tree and a gravel parking pad, and a grassed rear yard enclosed by a board fence (partially) and shrubs.

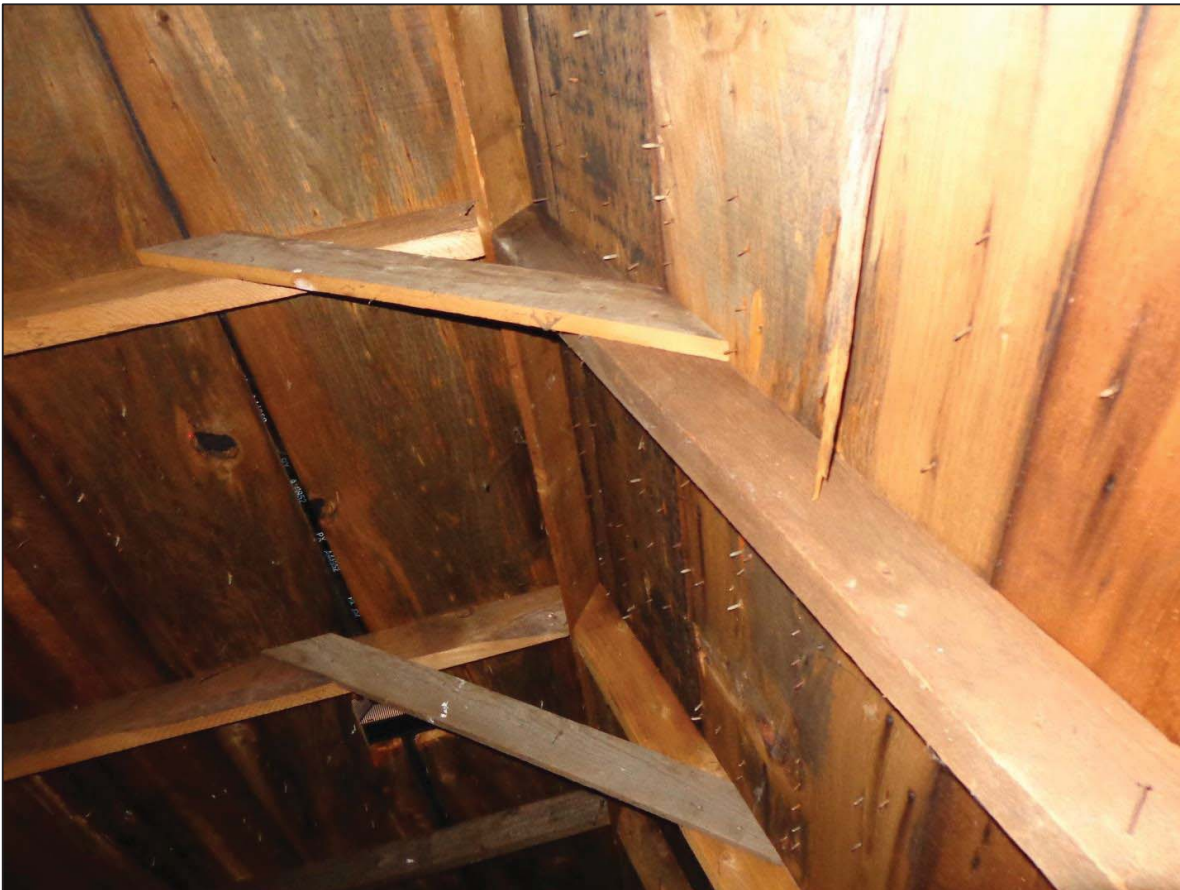
3. View of Roof Framing.

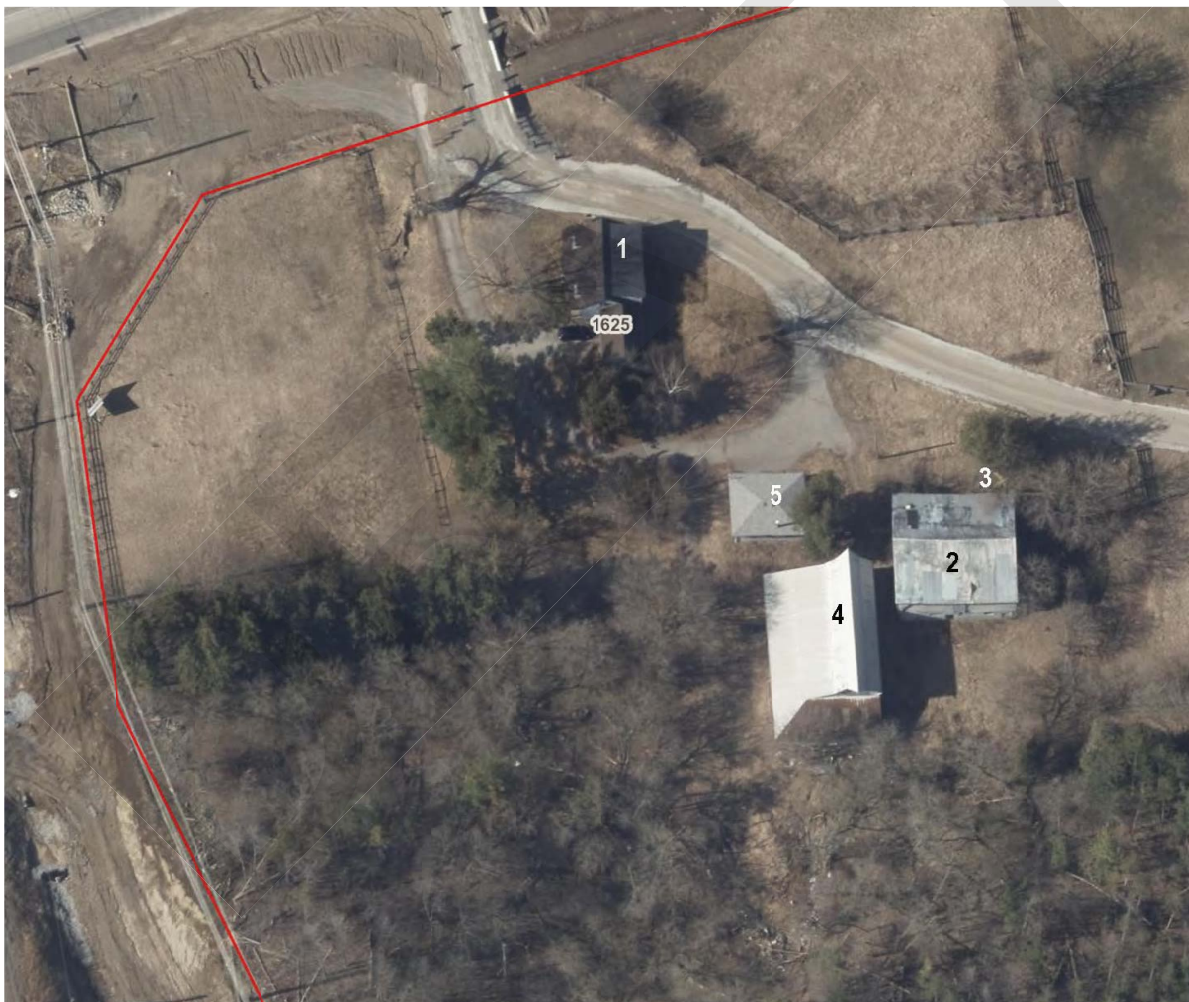
- a two-storey, post-1927 frame residence (Figure 8, #1);
- a late 19th century bank barn (Figure 8, #2);
- remains of an early 20th century concrete silo or cistern (Figure 8, #3);
- an early 20th century outbuilding with a mid-20th century addition (Figure 8, #4); and,
- a detached mid-20th century garage (Figure 8, #5).

Figure 8: 1625 St. John's Sideroad, current conditions (base map source: YorkMaps, 2018)

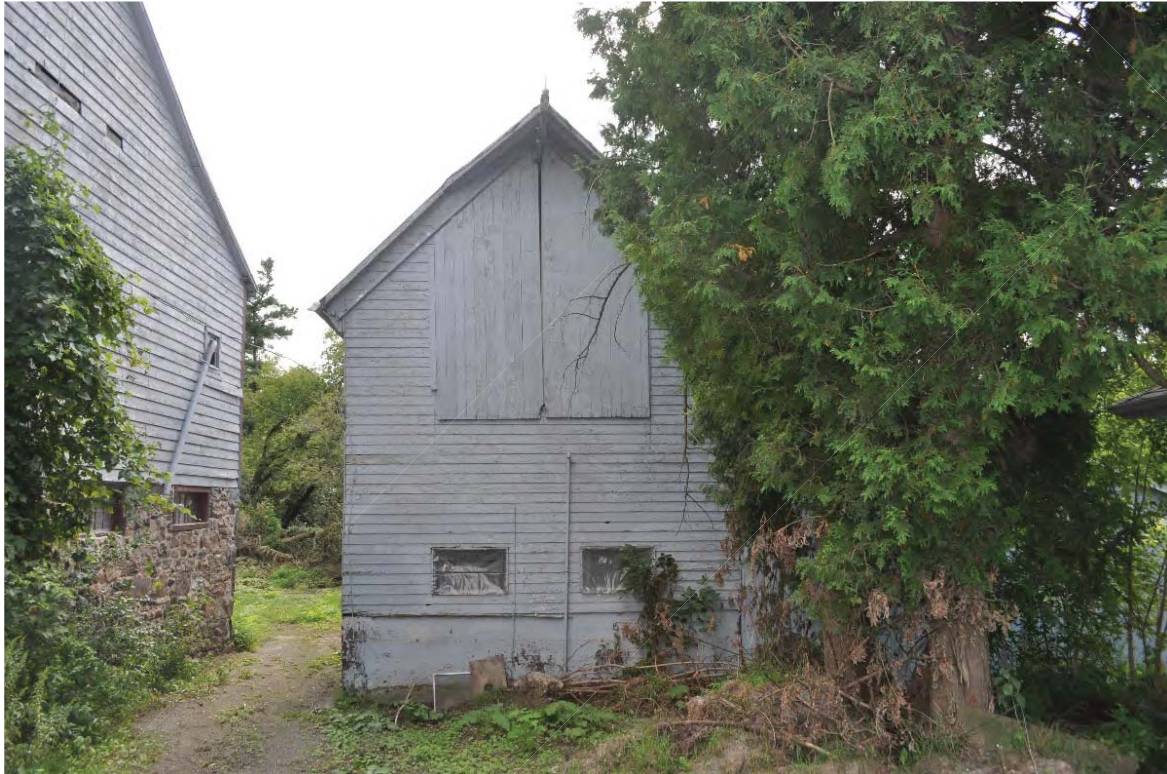
A second, two-storey outbuilding is located immediately west of the barn. This outbuilding is a simple, wood-clad, rectangular structure on a concrete foundation with a metal, gable roof. Additions were added along the west and south sometime between 1927 and 1954 and there is evidence of 20th century intervention for expansion, maintenance, and change of use (Photo 18 to Photo 20).

Photo 18: Outbuilding, north facade (CU 2018).

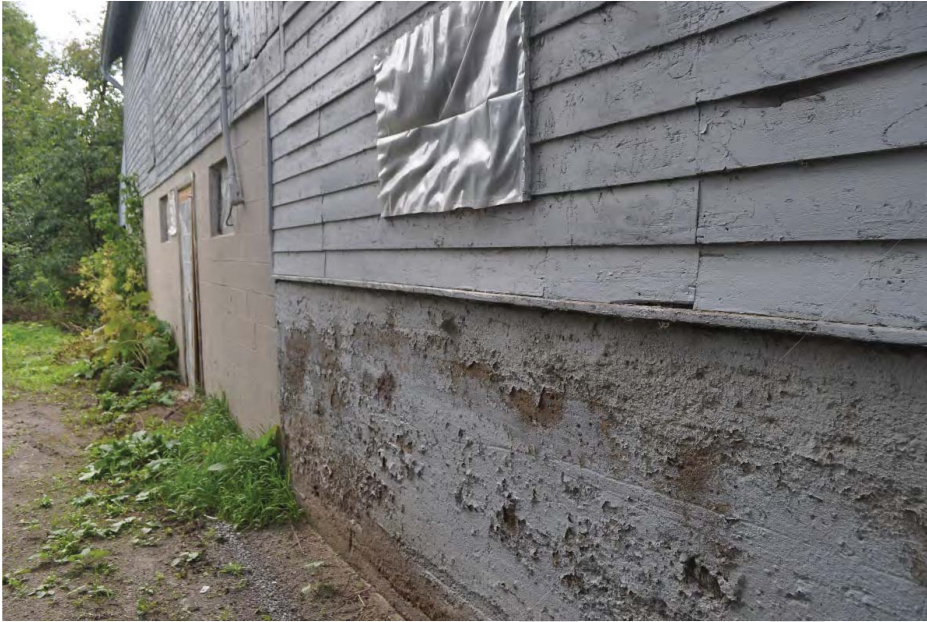
Photo 19: Outbuilding, east elevation foundations (CU 2018).

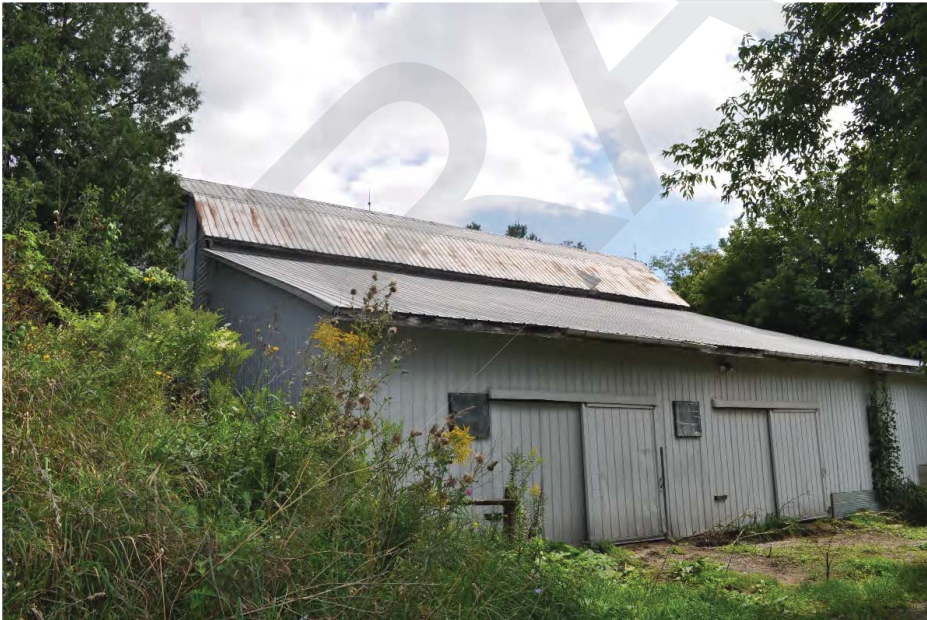
Photo 20: Outbuilding, mid-20th century addition, west facade (CU 2018).

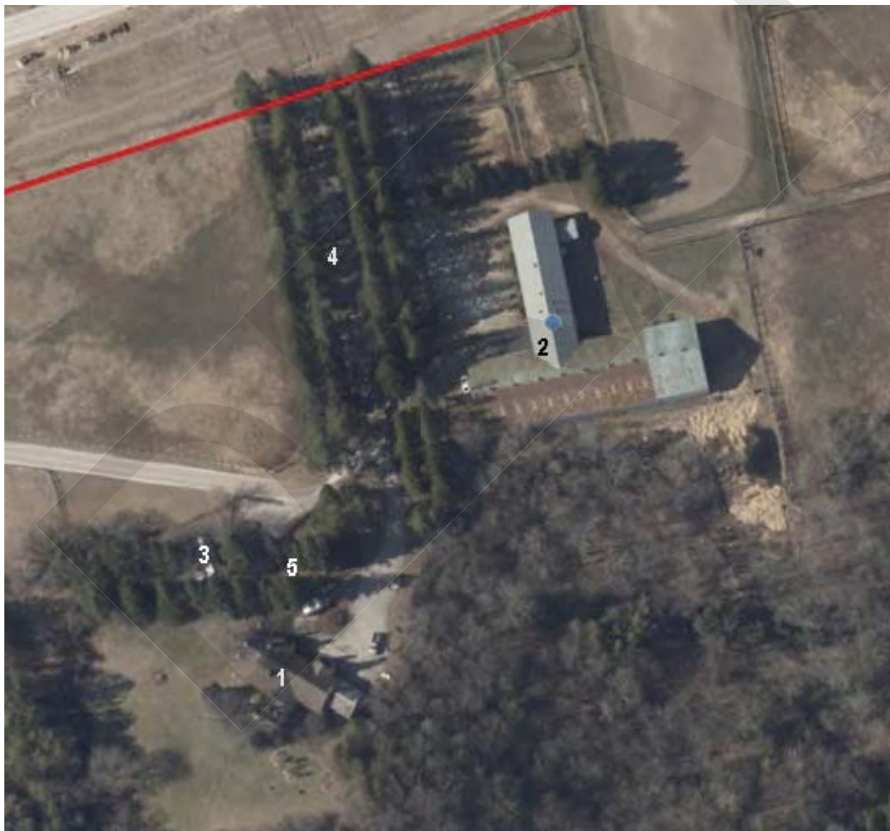
Given the late-20th century date of construction of the majority of the landscape and its components, the small cottage, north of the c.1960 residence is the focus of the physical description below. **It should be noted that the interior of the cottage was not accessed, due to significant safety concerns.**

Figure 9: 1675 St. John's Sideroad, building complex, current conditions (base map source: YorkMaps, 2018)
