# Heritage Advisory Committee Meeting Agenda

Tuesday, March 5, 2019 7 p.m.

HAC19-001 – Request to Remove a Property from the Aurora Register of Properties of Cultural Heritage Value or Interest 97 Wellington Street East

## 2. HAC19-002 – Heritage Permit Application 70-72 Centre Street East File: NE-HCD-HPA-19-02

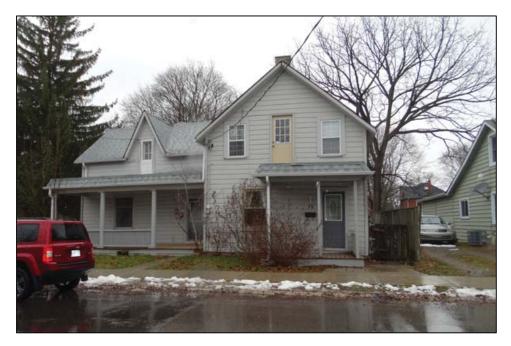
Figure 5: Below: South façade, 2018. Note the changes from 1916.

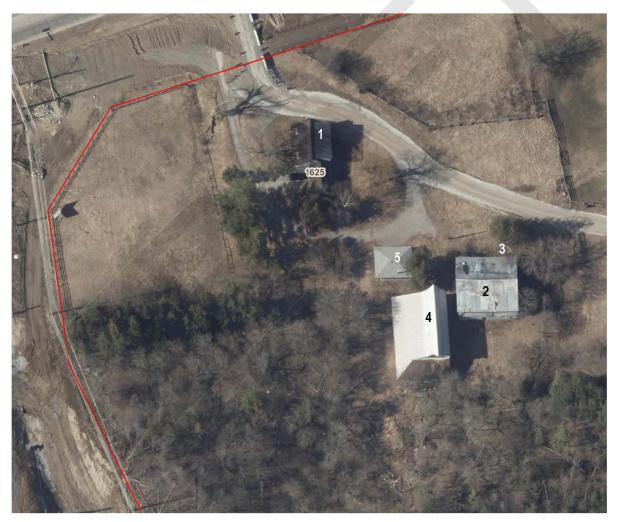
Figure 8: 1625 St. John's Sideroad, current conditions (base map source: YorkMaps, 2018)

Key features of the smaller of the two complexes, 1625 St. John's Sideroad (Figure 8), include:

- a two-storey, post-1927 frame residence (Figure 8, #1);
- a late 19<sup>th</sup> century bank barn (Figure 8, #2);
- remains of an early 20<sup>th</sup> century concrete silo or cistern (Figure 8, #3);
- an early 20<sup>th</sup> century outbuilding with a mid-20<sup>th</sup> century addition (Figure 8, #4); and,
- a detached mid-20<sup>th</sup> century garage (Figure 8, #5).

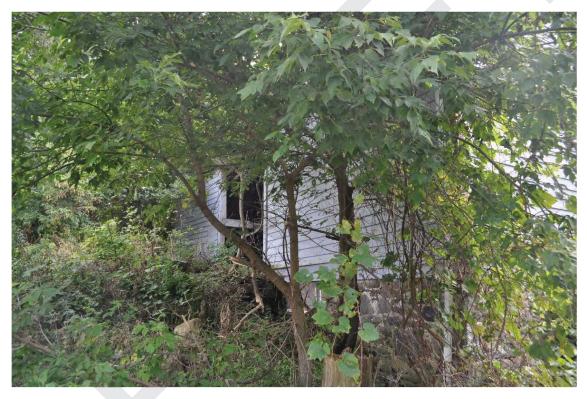
Photo 11: Barn, front (north) facade (CU 2018).

One of the key components of 1625 St. John's Sideroad considered for its cultural heritage value or interest, is the roughly 14m x 15m barn located south of the residence. The structure is constructed on a rectangular plan with an aluminum gable roof. Its design makes use of the existing topography, being one storey on the front (north) façade and two storeys at the rear and sides (Photo 11 to Photo 15). The foundation of a mid-20<sup>th</sup> century concrete silo or cistern is located along the north façade (Photo 12). The structure is clad in horizontal wood cladding and - although portions of the fieldstone foundation likely dating to the late 19<sup>th</sup> century are extant along the front and side elevations (Photo 11 to Photo 14) – there is evidence of significant intervention in the mid-20<sup>th</sup> century. This 20<sup>th</sup> century intervention includes a complete rebuilding of the rear (south) foundation wall and the replacement and bracing of interior beams and walls (Photo 15 to Photo 17).

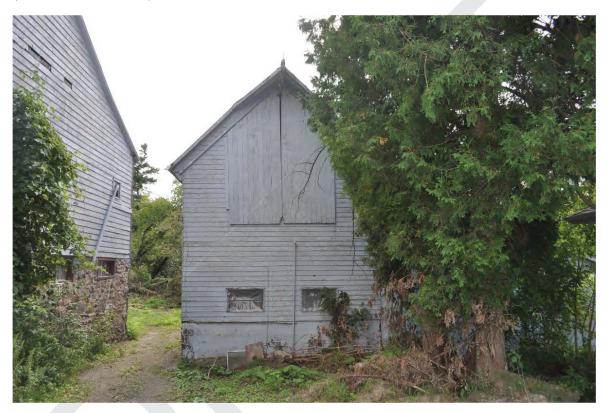
Photo 18: Outbuilding, north facade (CU 2018).

A second, two-storey outbuilding is located immediately west of the barn. This outbuilding is a simple, wood-clad, rectangular structure on a concrete foundation with a metal, gable roof. Additions were added along the west and south sometime between 1927 and 1954 and there is evidence of 20<sup>th</sup> century intervention for expansion, maintenance, and change of use (Photo 18 to Photo 20).

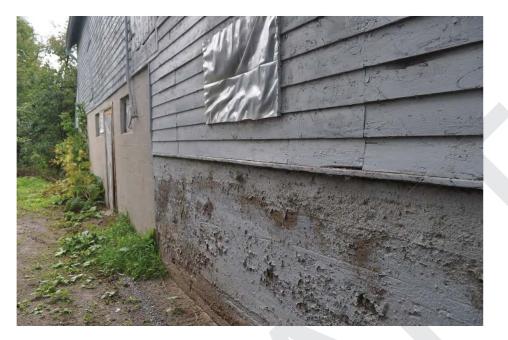
Photo 19: Outbuilding, east elevation foundations (CU 2018).

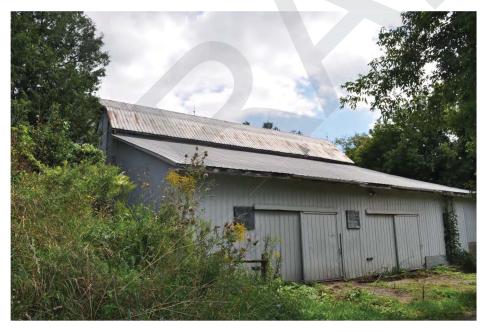
Photo 20: Outbuilding, mid-20th century addition, west facade (CU 2018).

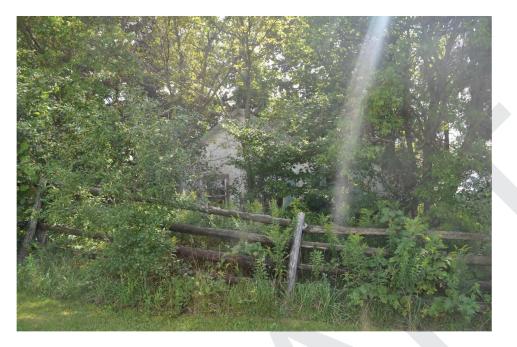
Photo 32: Cottage, north facade (CU 2018).

Given the late-20<sup>th</sup> century date of construction of the majority of the landscape and its components, the small cottage, north of the c.1960 residence is the focus of the physical description below. It should be noted that the interior of the cottage was not accessed, due to significant safety concerns.

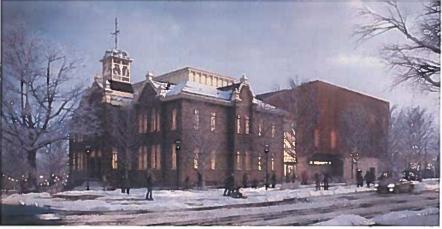
Rendering of the proposed south-east elevation (RAW, 2019).
