**Heritage
Advisory Committee
Meeting Agenda**

**1. HAC19-005 – Request to Remove a Property from the Aurora Register of Properties of Cultural Heritage Value or Interest
84 Mosley Street East**

**2. HAC19-006 – Request to Remove a Property from the Aurora Register of Properties of Cultural Heritage Value or Interest
11 Irwin Avenue**

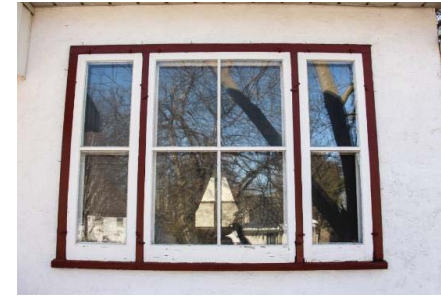
The side door hood is of simple construction with a gable roof, a panelled front wall and supported by wooden struts (Figure 22).

Figure 22 - Chimney; front right window; side door hood; front porch steps and railing. (Photos: RHC 2019)

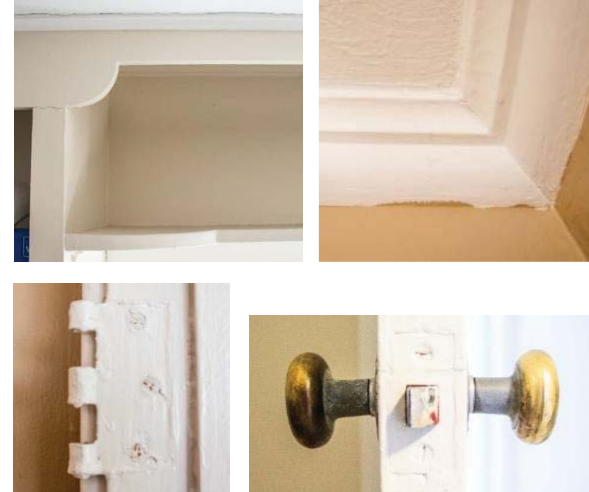
The simple interior door handles and hinges and forced air heating grates appear to be typical mid-20th century stock materials (Figure 29). Interior walls appear to be clad with a gypsum type board as opposed to plaster.

Figure 29 - Kitchen cupboard; crown molding; door hinge; door handles. (Photo: RHC 2019)

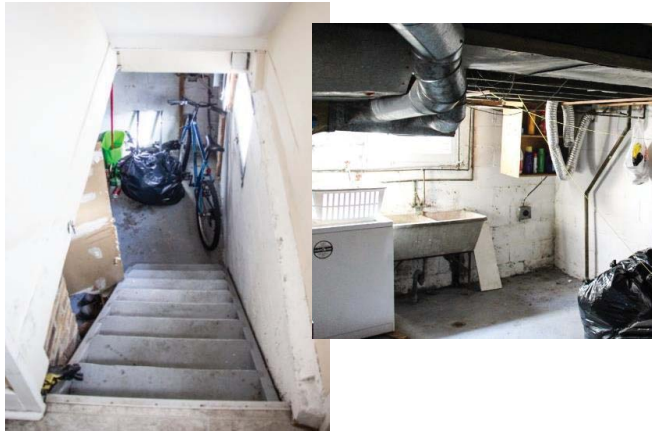
Figure 32 - Basement stair; concrete laundry sink under basement window. (Photo: RHC 2019)

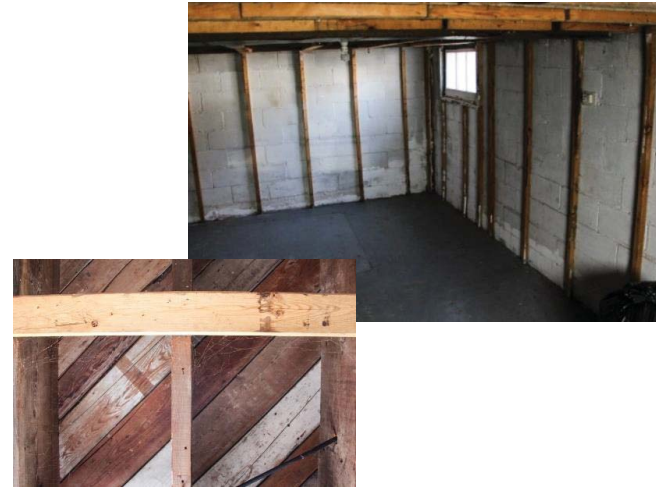
Figure 33 - Concrete block basement wall with strapping; diagonal main floor boards seen from basement, (Photo: RHC 2019)
